## 3000 kW, 6600V, 12 pole, Synchronous motor for Gold Mine in Ghana

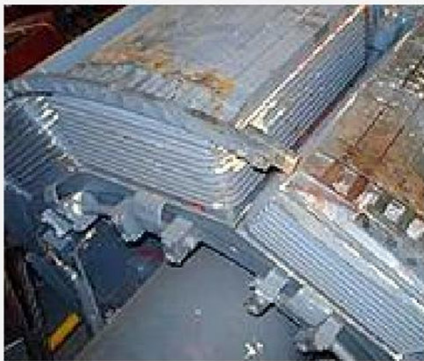
The starting cage had failed. M&C removed some of the old rotor bars as well as a section from the short circuit cage at conducted chemical analysis on them in order to identify the exact material used since we know that matching these parameters will be critical for the correct starting of the motor, i.e. in order to achieve enough starting torque and a reduced starting current.

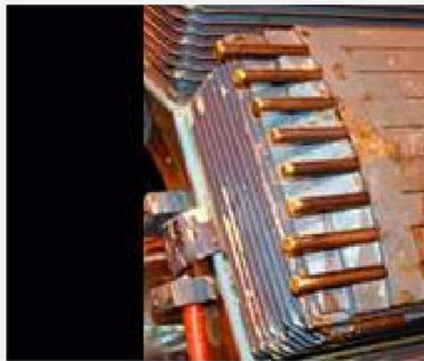
We correctly specified these special alloy starting cage bars and had them manufactured and imported from Europe.

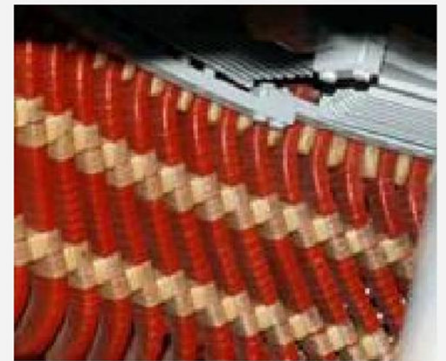
The completed rotor is shown here inside the stator winding.

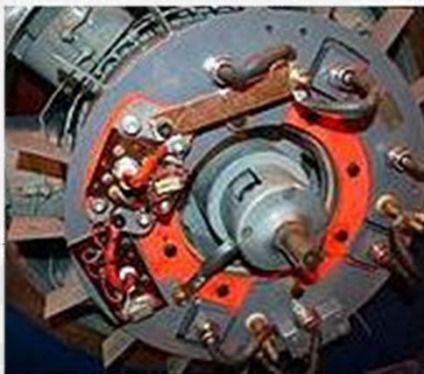
The synchronization circuit was also replaced.
